Under Pressure

Stress-Reducing Tactic for Enclosures

By Gary Chan

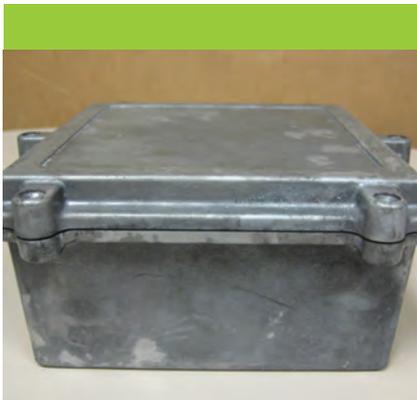
Figure 1. Aluminum housing used in testing.

The team purchased 4 commercially available outdoor housings similar to those used in the telecommunication industry. These 2-liter housings were constructed of aluminum with a silicone gasket, and they were rated to IP67. (Figure 1).

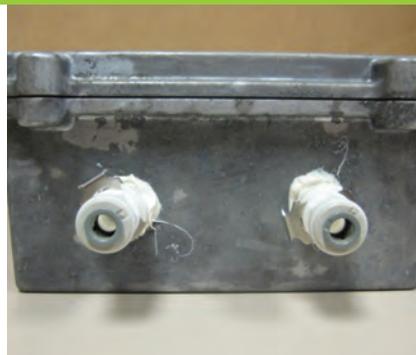
Figure 2. Aluminum housing with ports installed for pressure and temperature probes.

Pressure and temperature probes were installed in each enclosure (Figure 2), and an M12x1.5 Series Screw-In Vent was installed in 2 of the enclosures to allow pressure to equalize during the testing process. (Figure 3) No electronics were installed inside the housings.

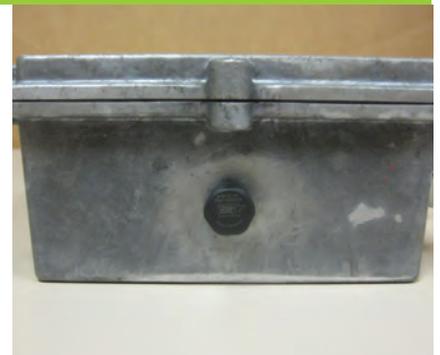
Figure 3. Aluminum housing with GORE® Protective Vent installed.

The screw-in vent installed in the 2 vented enclosures maintained a typical airflow of 405 milliliters/minute while providing IP67 water and particulate protection. With this level of airflow, the internal and external pressure remained equalized as the temperature changed, reducing the stress on the seals.

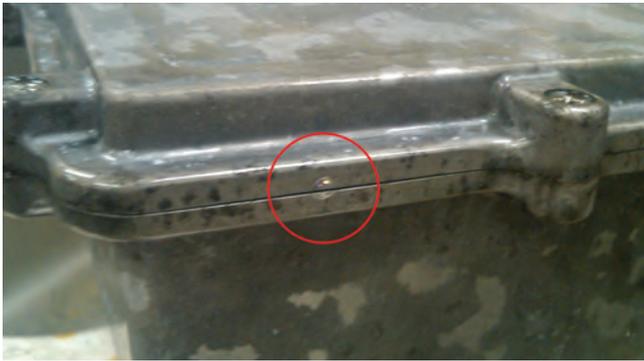
Figure 7. Enclosure visually inspected after the testing.

After the testing, the team followed the IEC 60068-2-1 standard protocol and visually inspected all 4 enclosures. They used a technique to determine potential leak paths by brushing a surfactant solution around the seals of each enclosure after the last cycle of cold temperature was completed. As the enclosures returned to ambient temperature, the internal air expanded, which

would cause bubbles to form at any leak paths. For the vented enclosures, no bubbles formed. However, bubbles did form around the gaskets of the sealed enclosures. (Figure 7) In addition, the team opened the enclosures and found no signs of integrity issues or long-term creep behavior with the polymer gaskets.
